TEMPERATURE AND PRESSURE PROFILES OBTAINED DURING BURN OF A SIDEWINDER MARK 17 MOD 5 MOTOR IN A 15,300 CUBIC-FOOT MAGAZINE

DL Technical Report No. TR-3139
September 1974

ABSTRACT

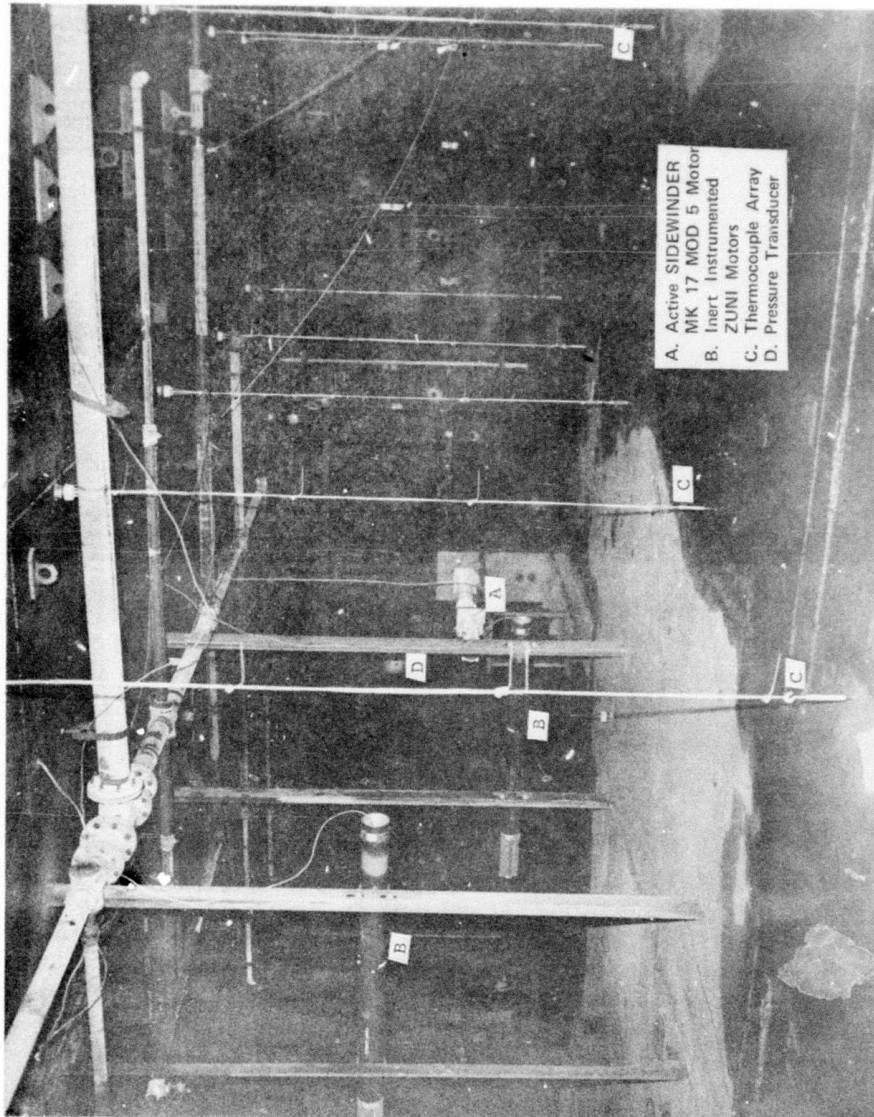
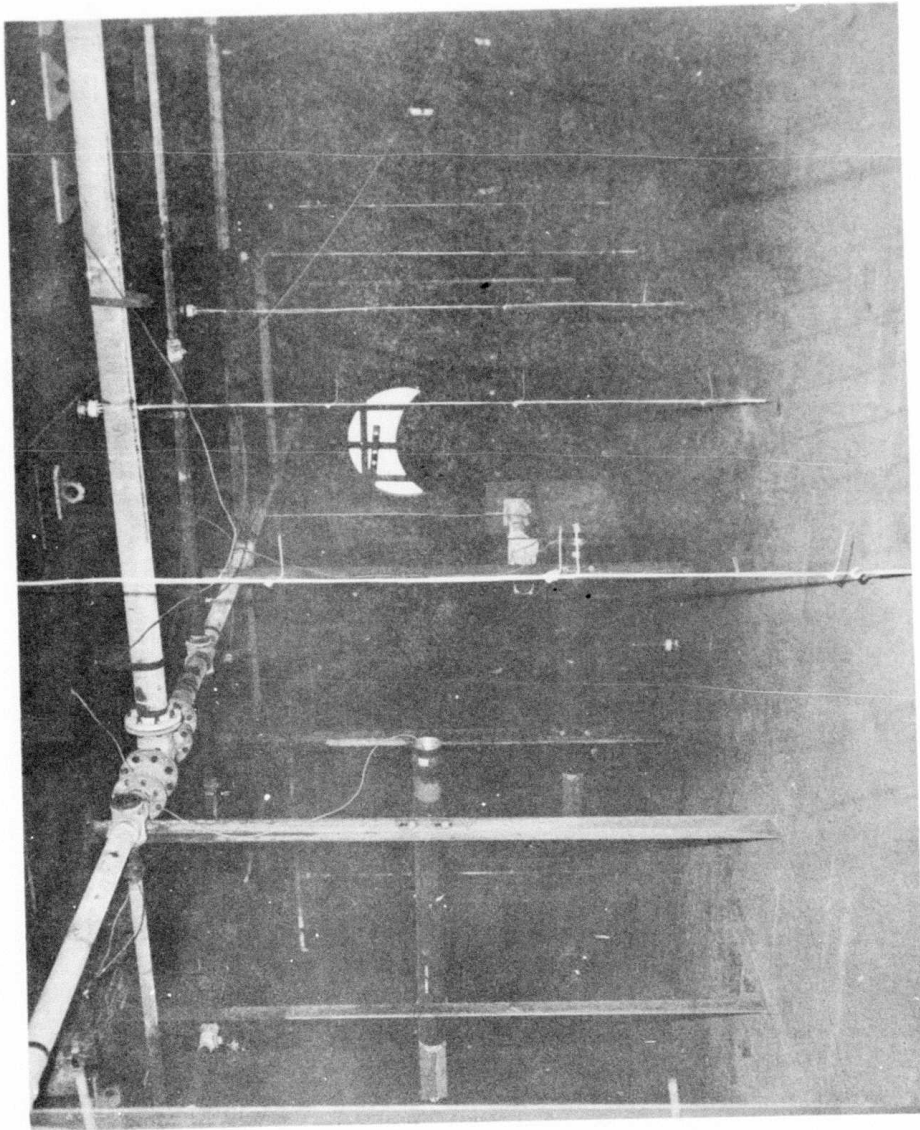
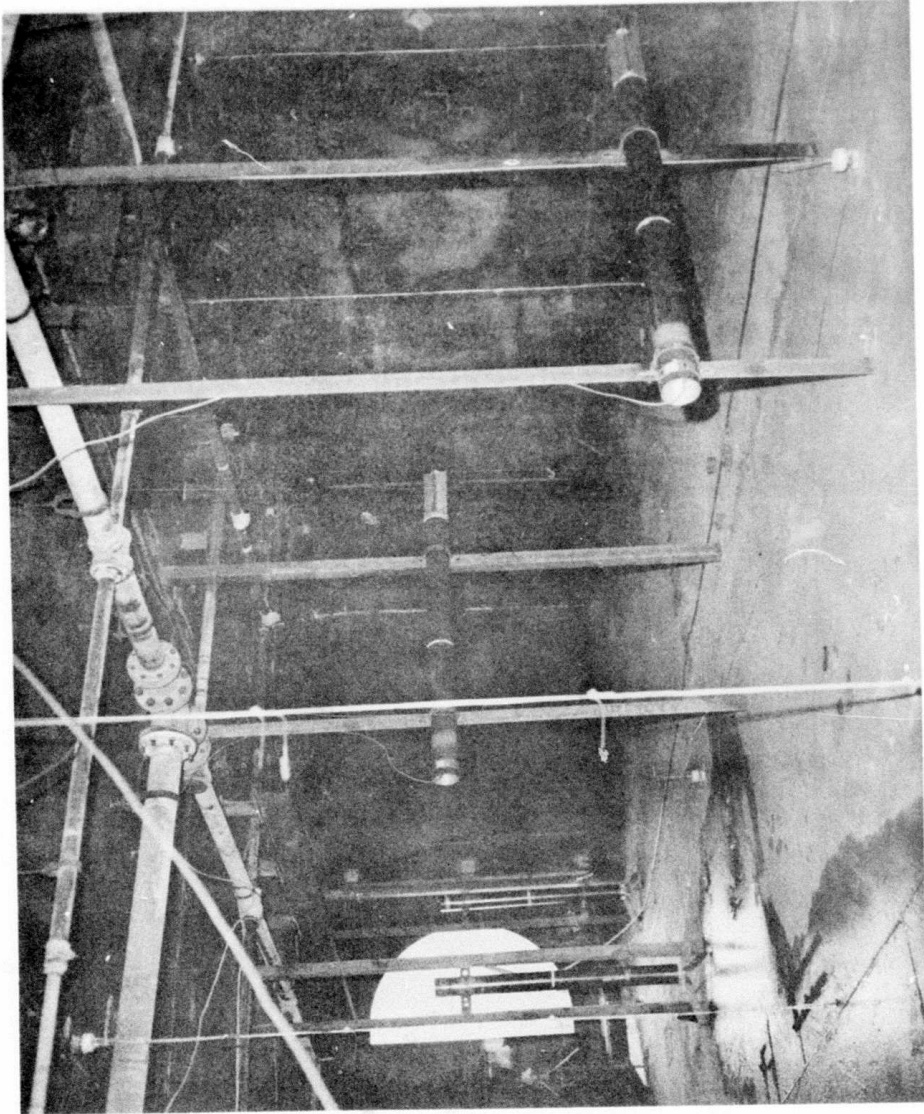
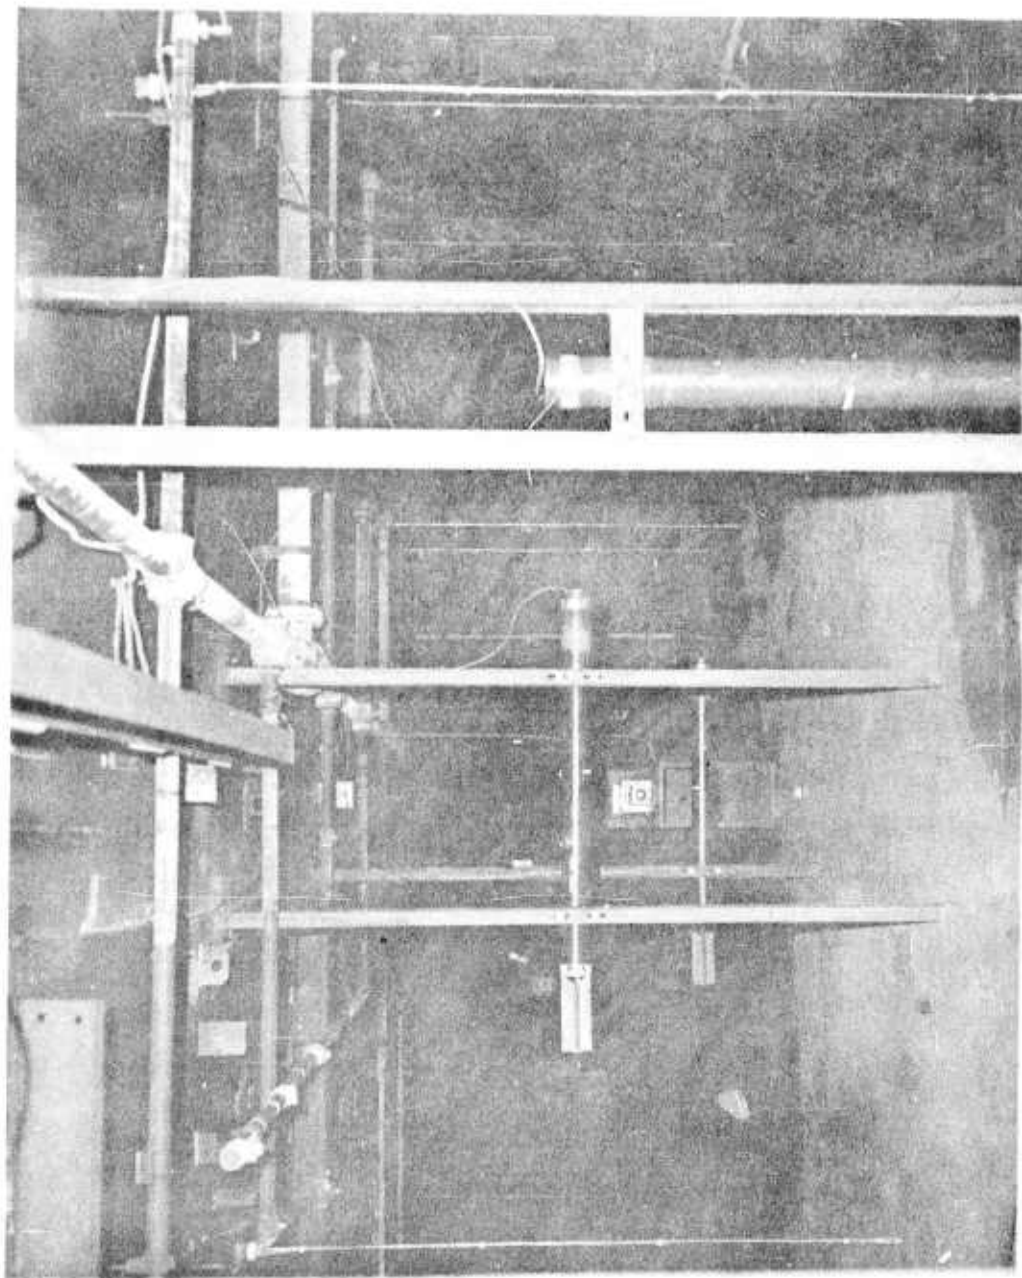
(9) Figures 5 through 8 of Appendix D are photographs of the magazine instrumentation array and ordnance (active SIDEWINDER MK 17 MOD 5 and inert, instrumented ZUNI motors) configuration.

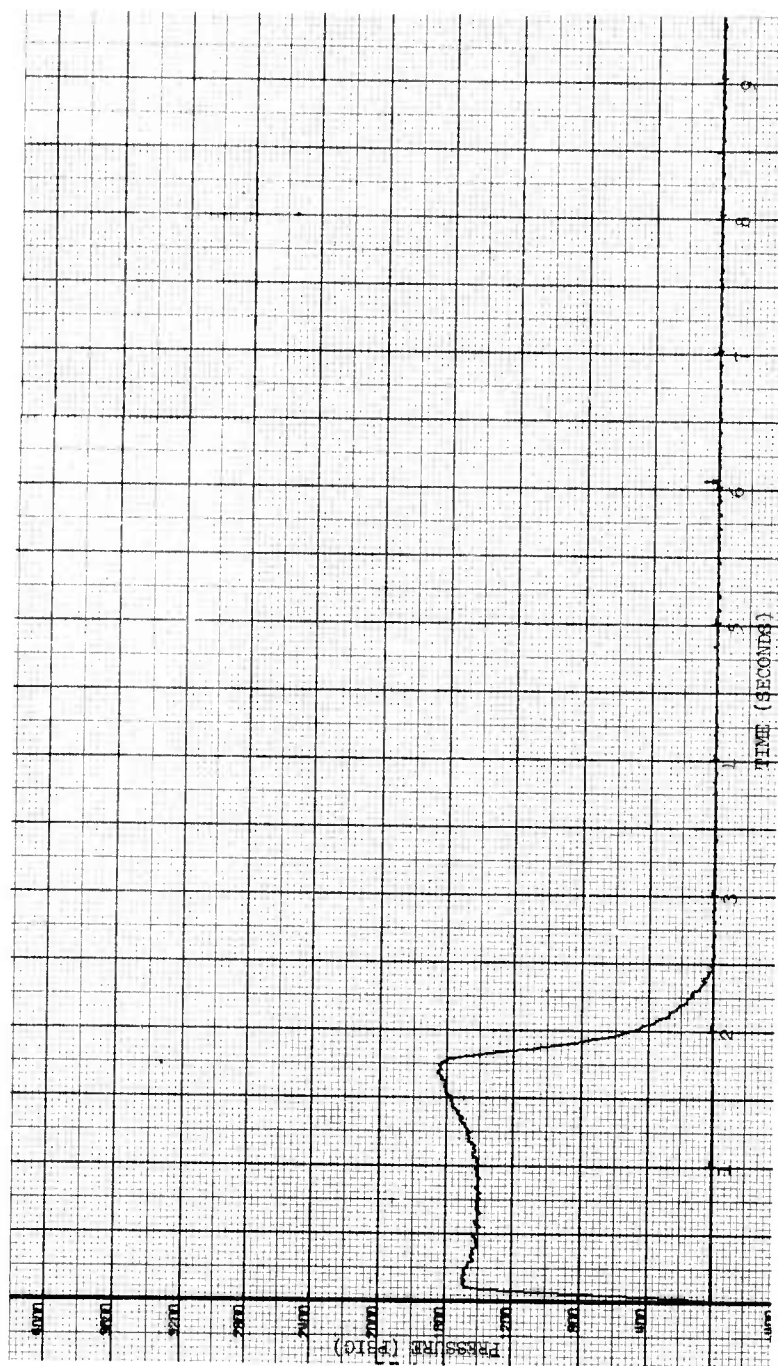
FIGURE E-1
SIDEWINDER MK 17 MOD 5 Motor Pressure
Test No. 2

(1) Figure 1 of Appendix E indicates that a normal motor burn with normal chamber pressure occurred.

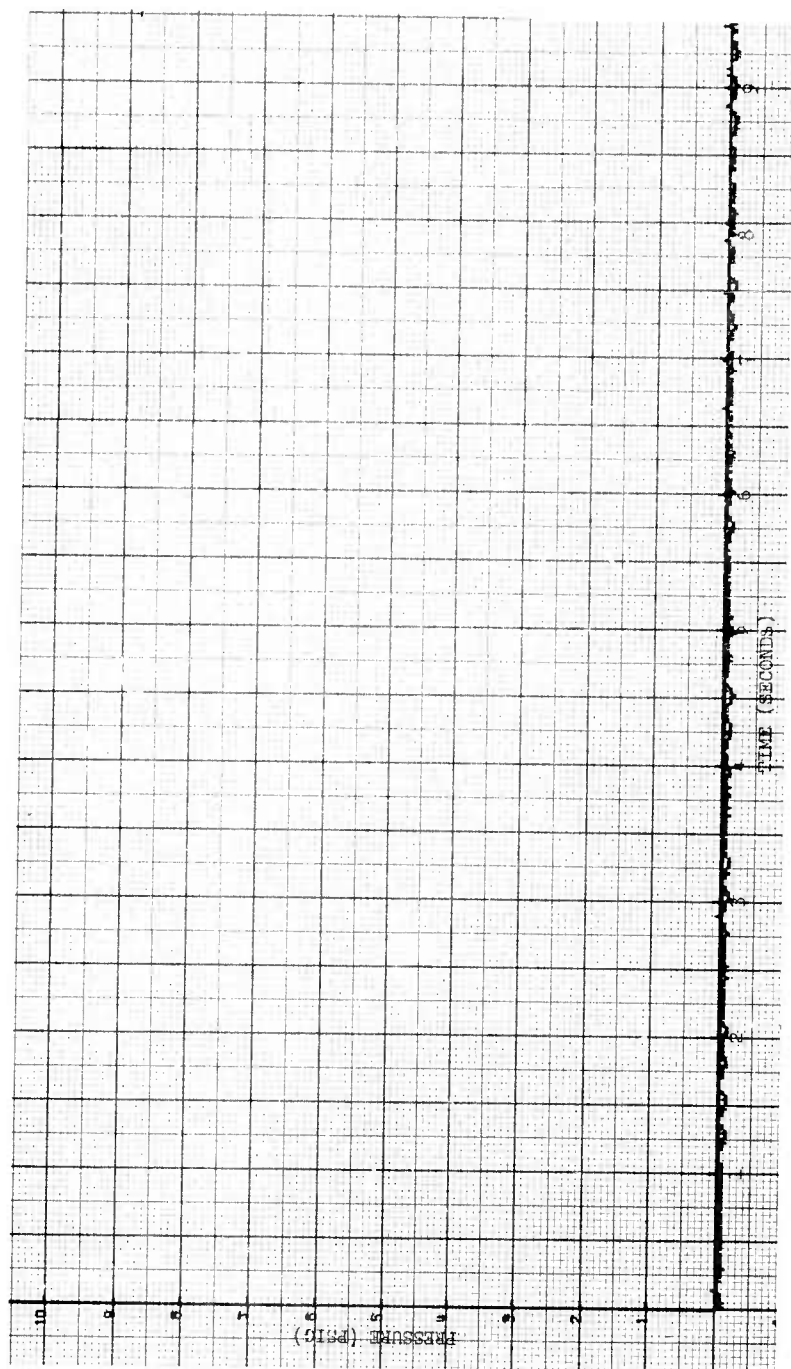
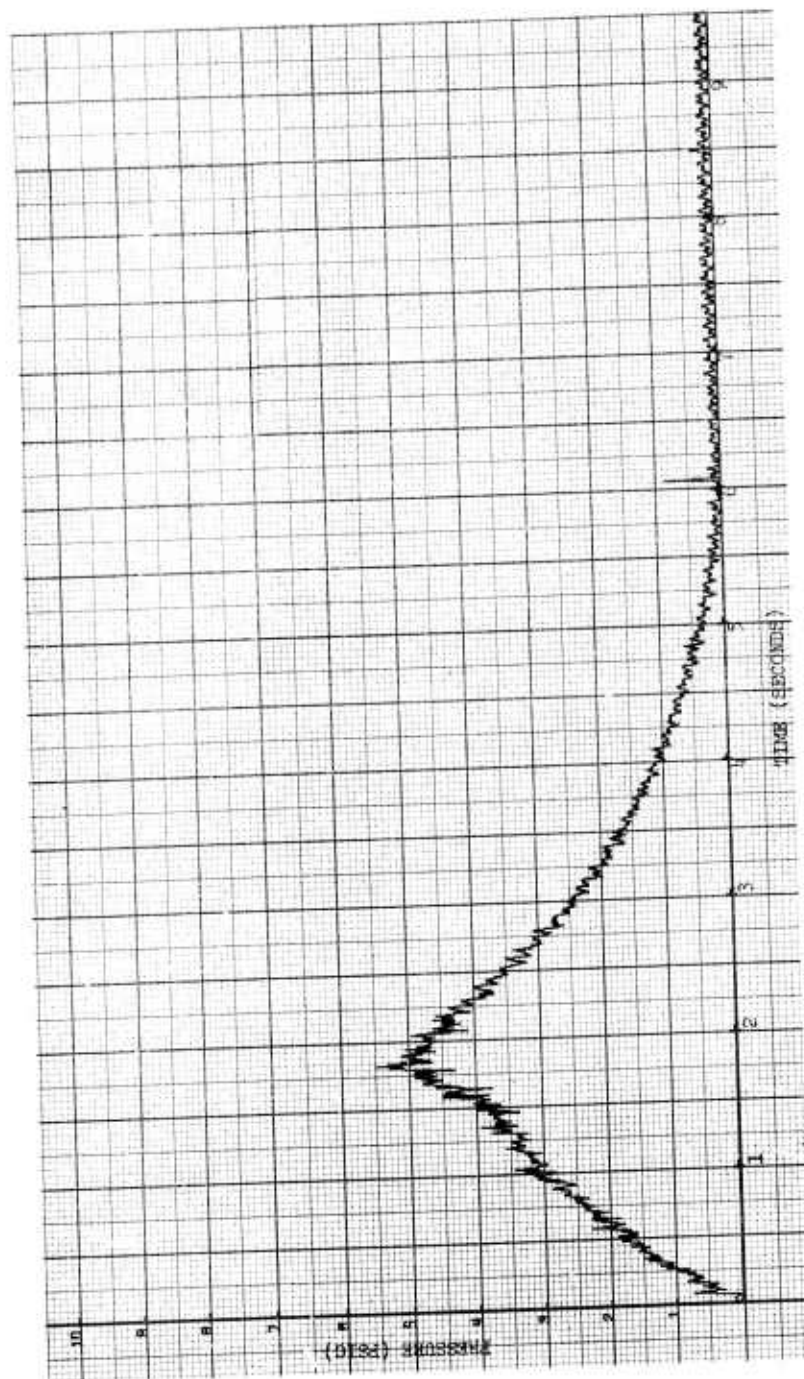
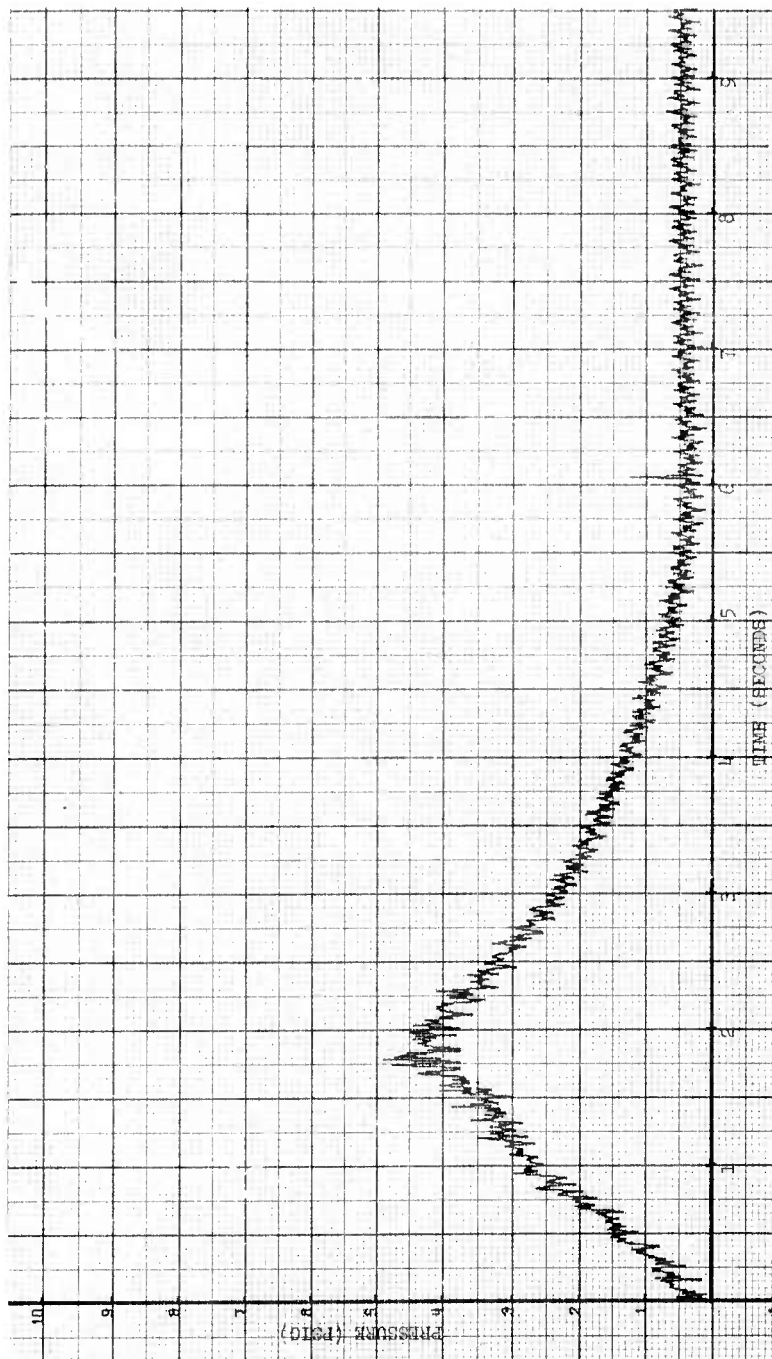
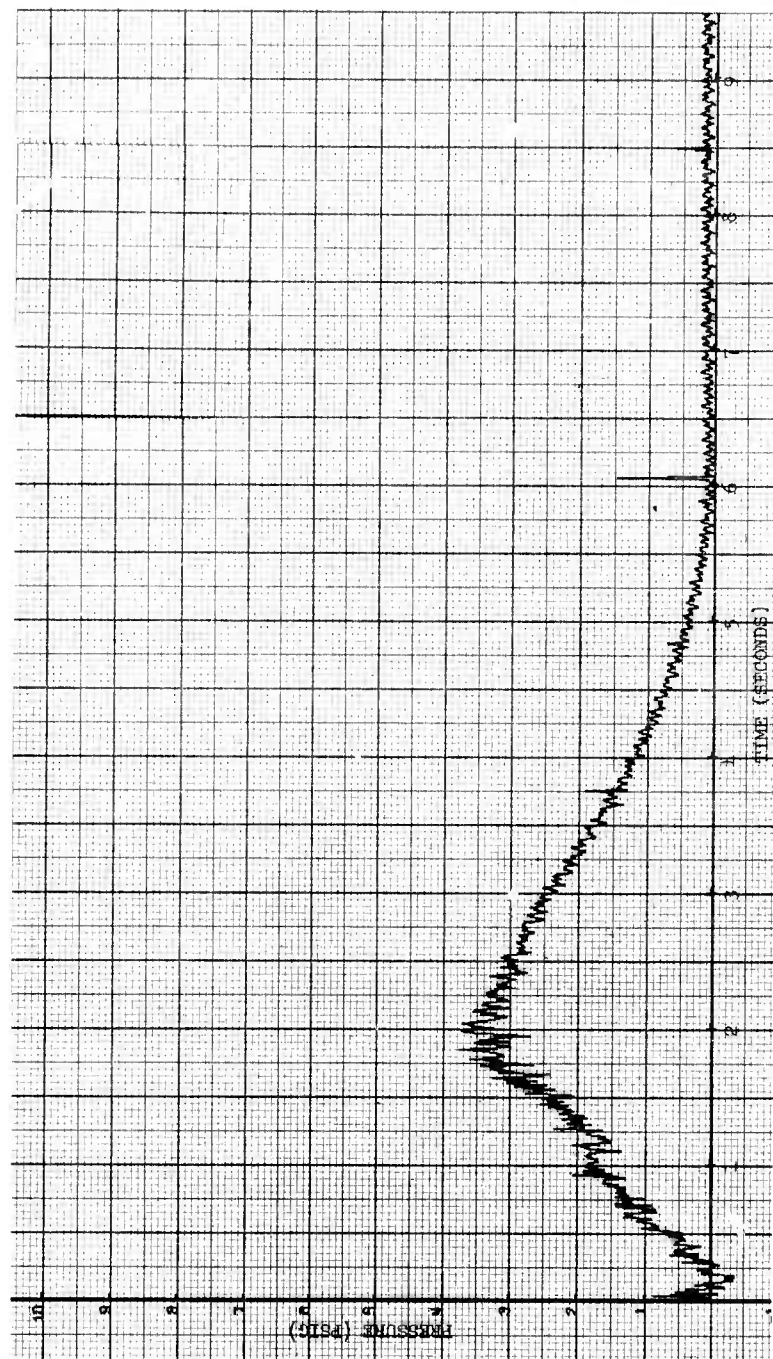
(2) The pressure profile in the test magazine ranged between 3.8 and 5.4 psig as shown in Figures 2 through 5 of Appendix E. Pressure gauge P1 failed during this test.
